Soluble Salts in Porous Materials:
Evaluating Effectiveness of their Removal

A THESIS

Historic Preservation

1999

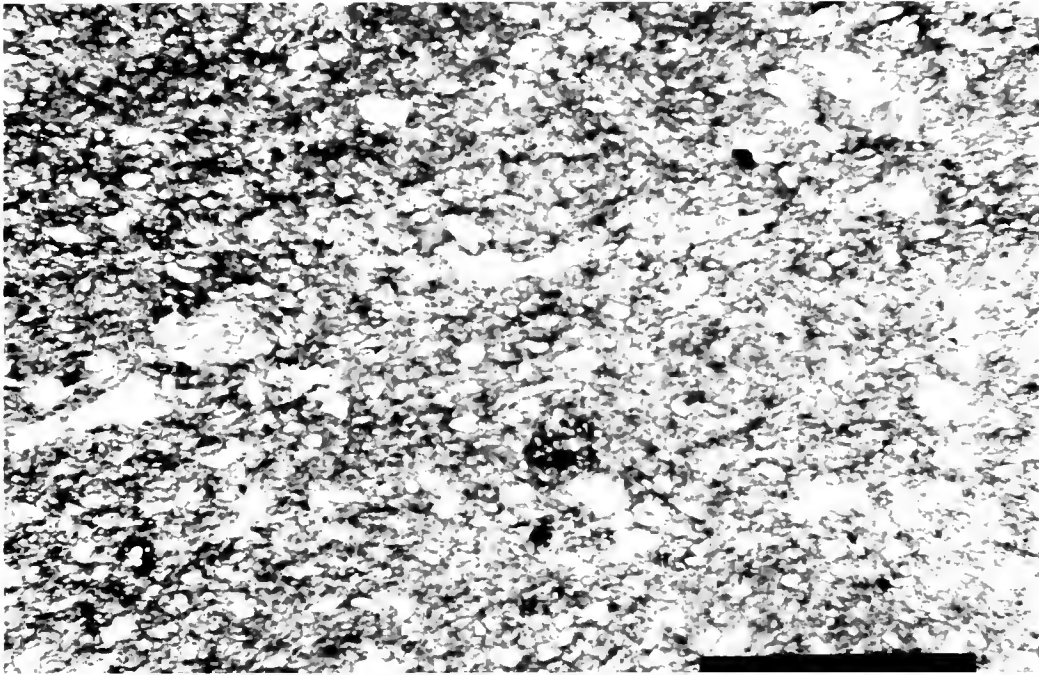
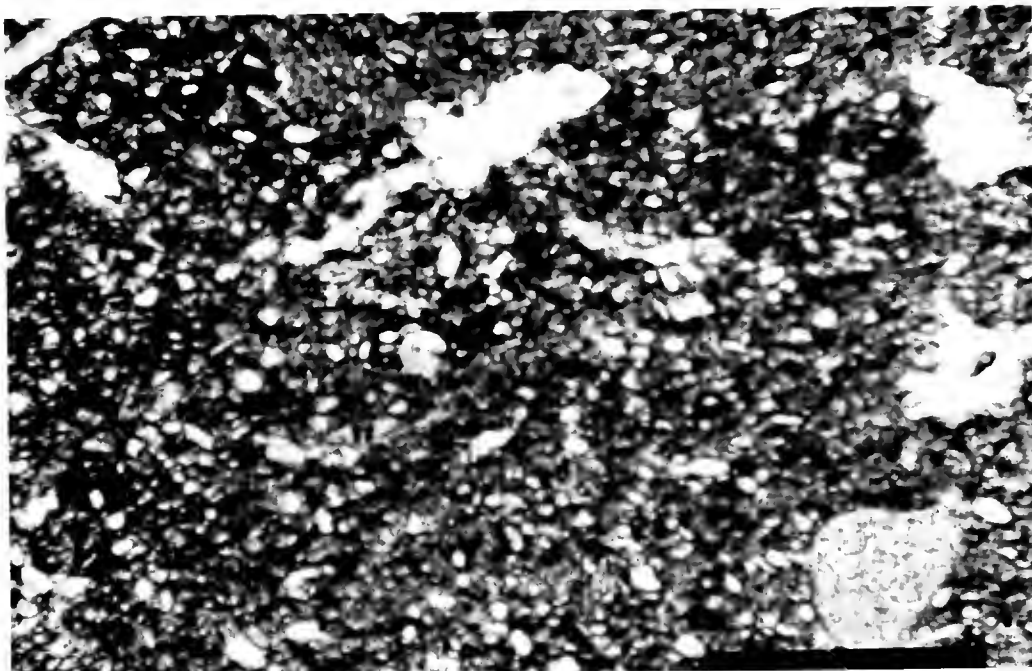
The mineralogical characterization of the earthenware tiles was carried out by polarized light microscopy of thin sections (Figures 1-4). As expected, all of the identifiable minerals are silicates. Approximately 15% of the sample was small quartz grains. Identified by their sharp angular shape and 90° extinction angle, the quartz grains were well sifted with most having both a major and minor axis of 2.3×10^{-4} millimeters. There were also some very fine grains of quartz, only distinguishable at magnifications greater than 100 times. A minimal amount of plagioclase feldspars were identified by their lamellar twinning.

Figure 1: Photomicrograph of Earthenware Tile Thin Section in Transmitted Light (Magnification 25x).

Figure 2: Photomicrograph of Earthenware Tile Thin Section under Cross Polarized Light (Magnification 25x).

Figure 3: Photomicrograph of Earthenware Tile Thin Section in Transmitted Light (Magnification 100x).

Figure 4: Photomicrograph of Earthenware Tile Thin Section in Crossed Polarized Light (Magnification 100x).

The grains were held together by a very fine grained red matrix composed of clays and the very fine quartz grains. Figures 1-4 show the general appearance of this material.

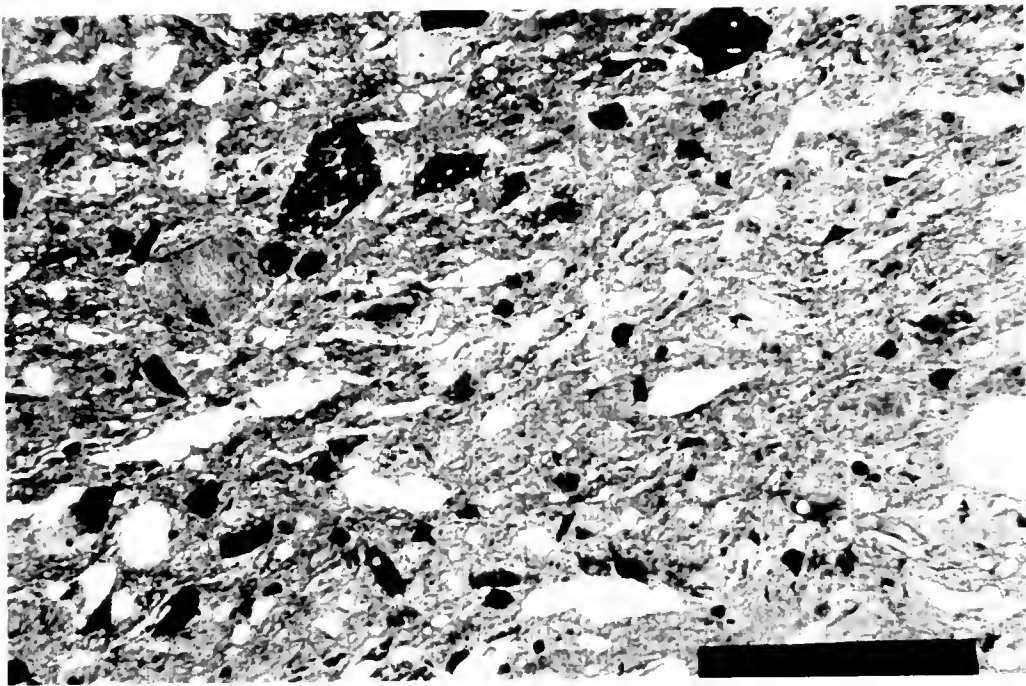
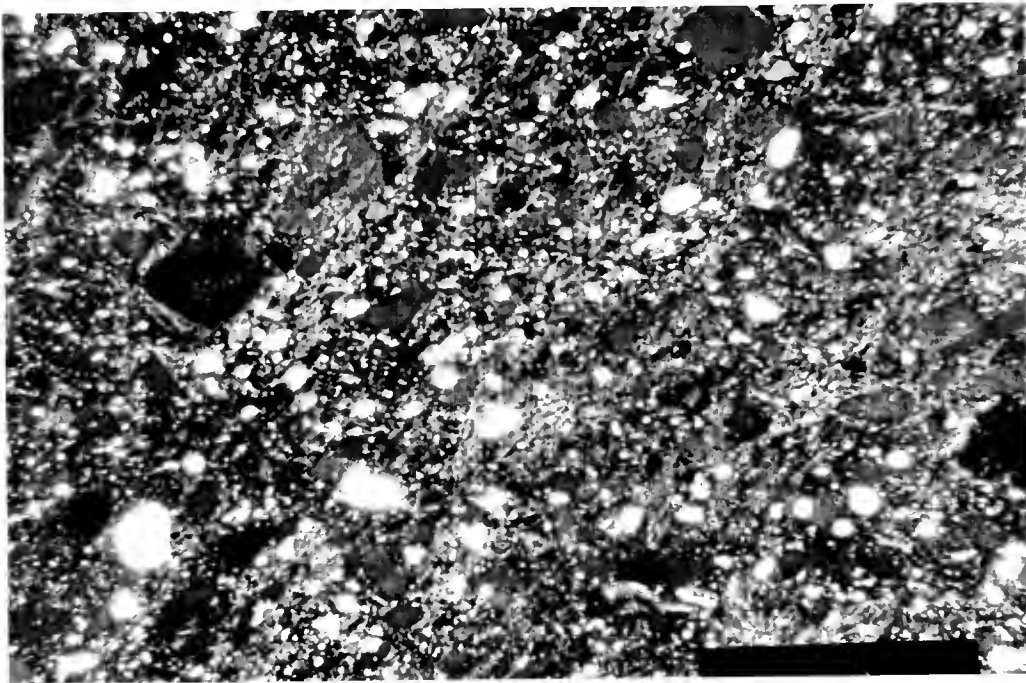
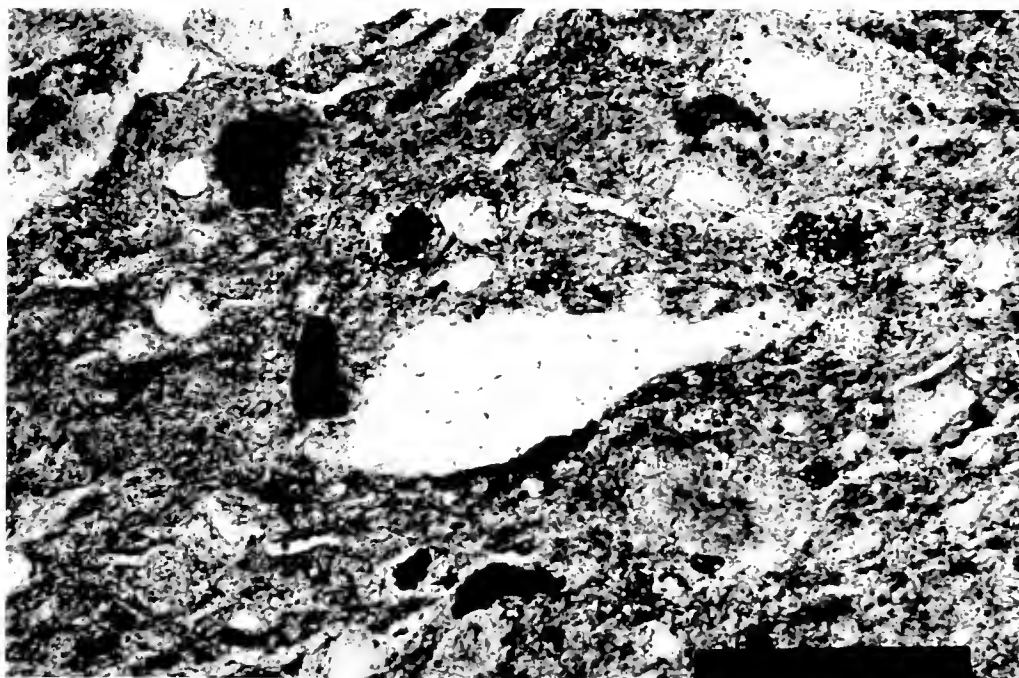
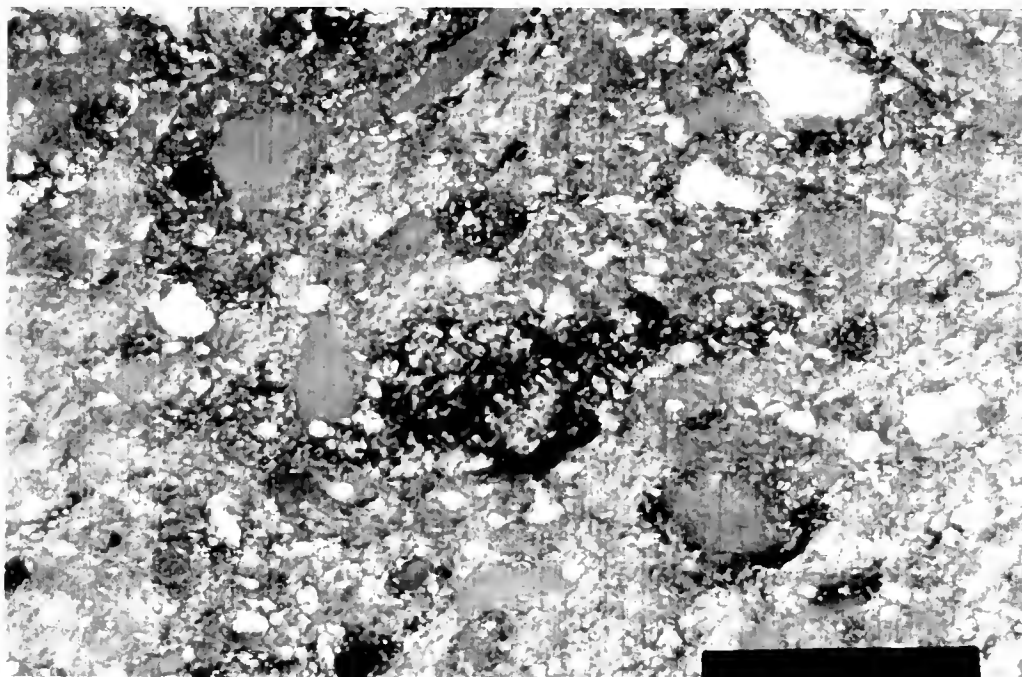
Figure 5: Photomicrograph of Stoneware Tile Thin Section in Transmitted Light (Magnification 25x).

Figure 6: Photomicrograph of Stoneware Tile Thin Section under Cross Polarized Light.

Figure 7: Photomicrograph of Stoneware Tile Thin Section under Transmitted Light (Magnification 100x).

Figure 8: Photomicrograph of Stoneware Tile Thin Section under Cross Polarized Light (Magnification 100x).

Pore characterization was carried out with microscopic analysis of thin sections (Figures 5-8). The measurements are provided in Appendix C. While the stoneware tiles had a much lower porosity, most of the pore area was a result of a small number of large pores. Unlike the earthenware tiles; however, there were few medium sized pores. The long and narrow pore shape in the stoneware is a result of the extrusion manufacturing process.

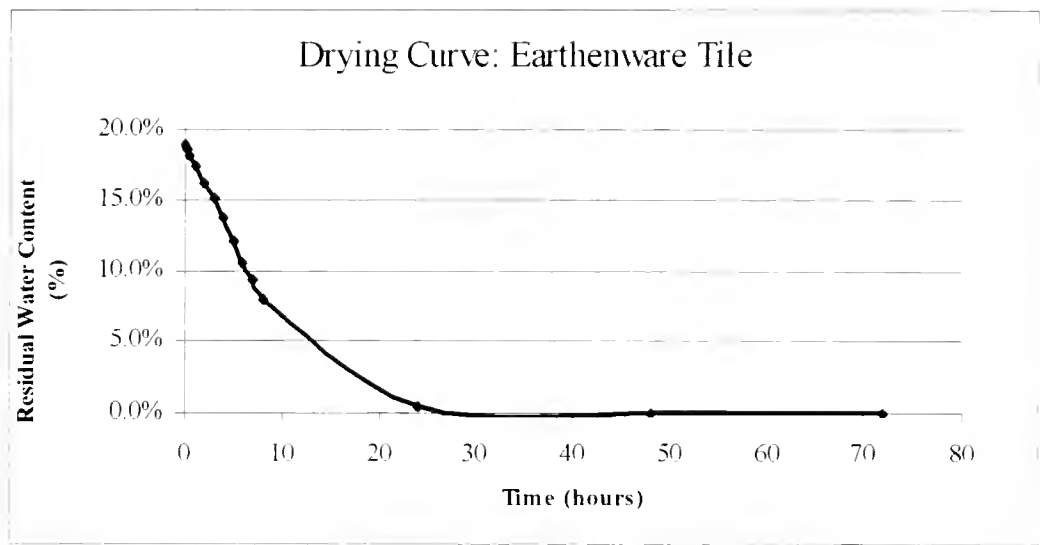
The drying rate of both tiles was determined according to NORMAL 29/88 and plotted in Graphs 1 and 2. The results confirm the observation of pore size determined by optical microscopy. The initial drying rate of the stoneware tiles was faster than the earthenware tiles because of the larger pores. The complete drying, however, took longer because of the finer pores evident in the boiling porosity test

Graph 1: Drying Rate of Earthenware Tile

The earthenware had a consistent drying rate because of the interconnectedness of the pores, as indicated by the porosity measurements.

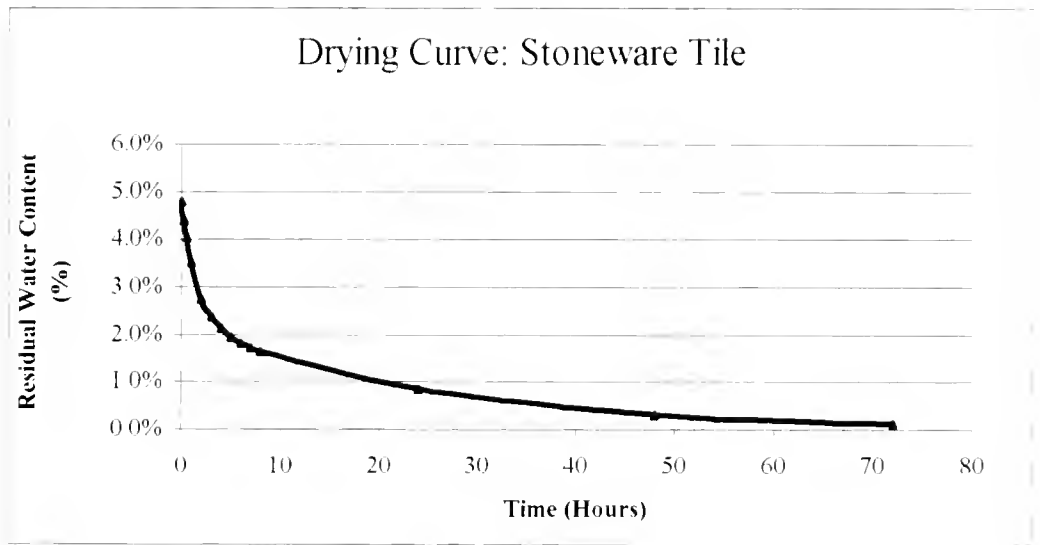
Graph 2: Drying Rate of Stoneware Tiles

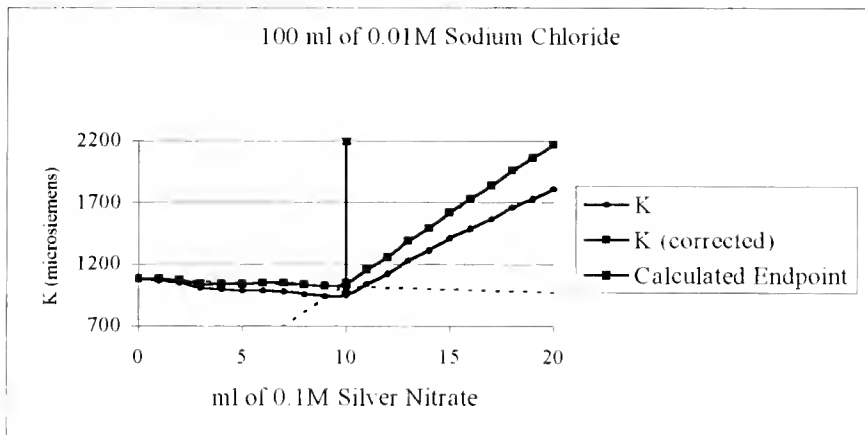
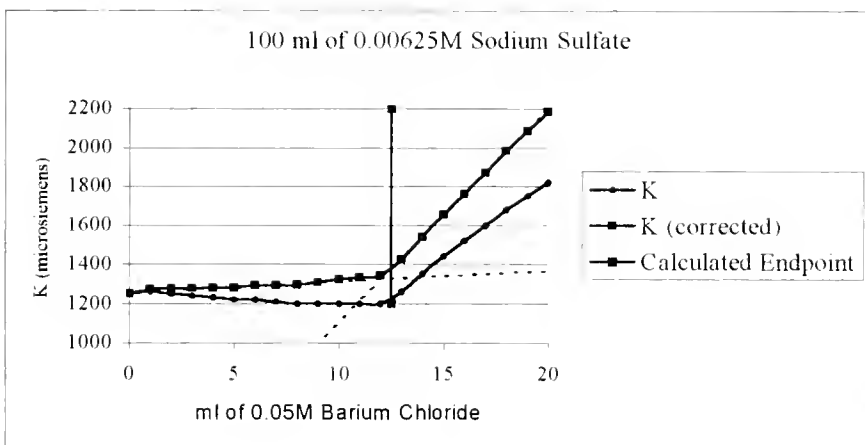
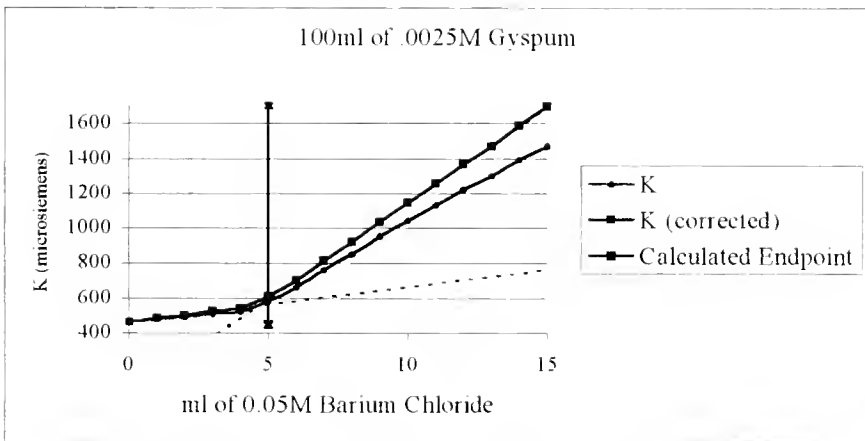
Test Titrations of Single Salts: Volume of Titrant vs. Conductance (K)

Graph 3: Chloride with Silver Nitrate

Graph 4: Sodium Sulfate with Barium Chloride

Graph 5: Gypsum with Barium Chloride

Solutions of 100 milliliters were prepared and titrated. The titration of the sodium chloride showed the highest degree of accuracy, accurate to 0.0001 grams per 100 milliliters (Graph 3). The titration of gypsum was the least accurate, accurate to 2 milligrams per 100 milliliters (Graph 5).

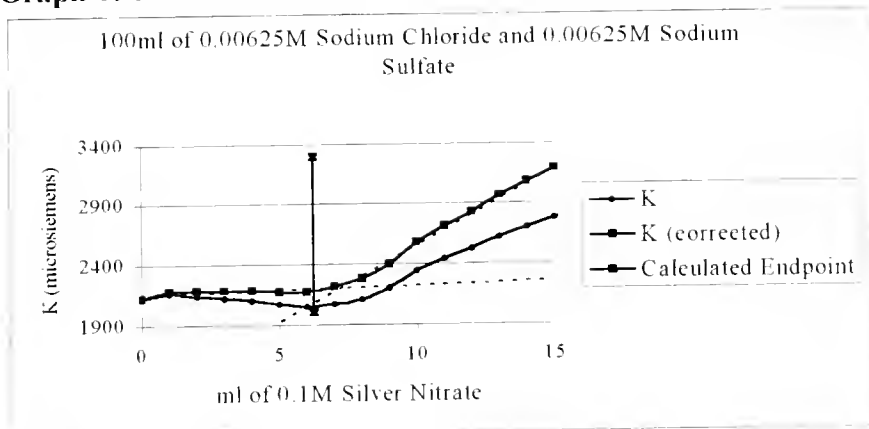
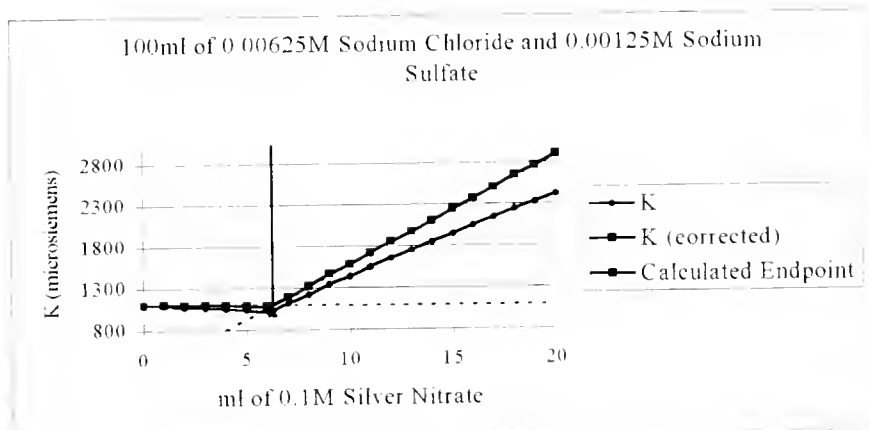
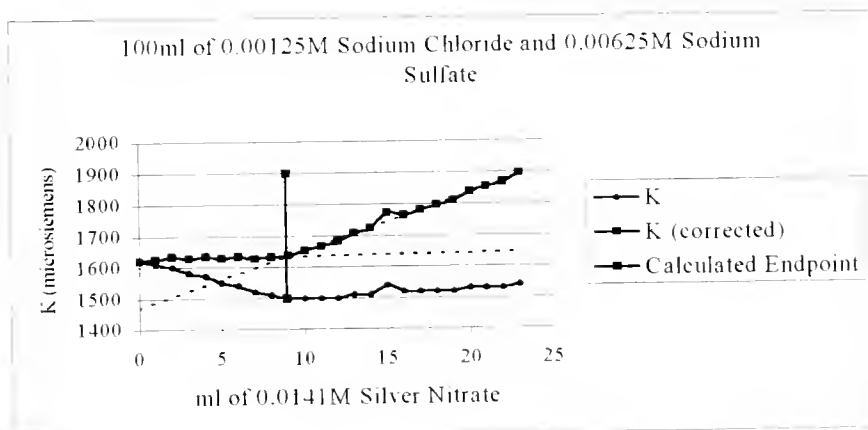
Test Titrations of Sodium Chloride in the Presence of Sodium Sulfate: Volume of Silver Nitrate vs. Conductance (K)

Graph 6: In the Presence of 0.00625M Sodium Sulfate

Graph 7: In the Presence of 0.00125M Sodium Sulfate

Graph 8: In the Presence of 0.00625M Sodium Sulfate

The test titration for sodium chloride in the most concentrated solution of sodium sulfate (0.00625 M) provided the least accurate results, 0.0056 grams above the calculated sodium chloride content (Table 7 and Graph 4). The endpoint of this graph is not as sharp as the single salt solution titrations. The curvature at the endpoint is a result of a small amount of silver ions reacting with the sulfate ions to form silver sulfate.

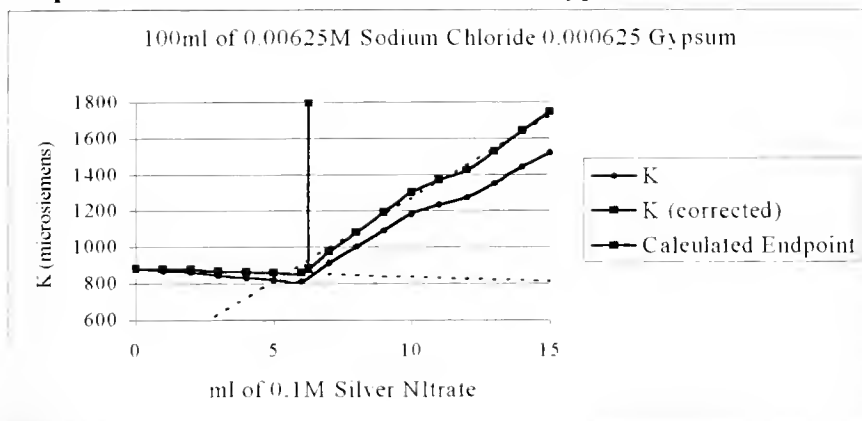
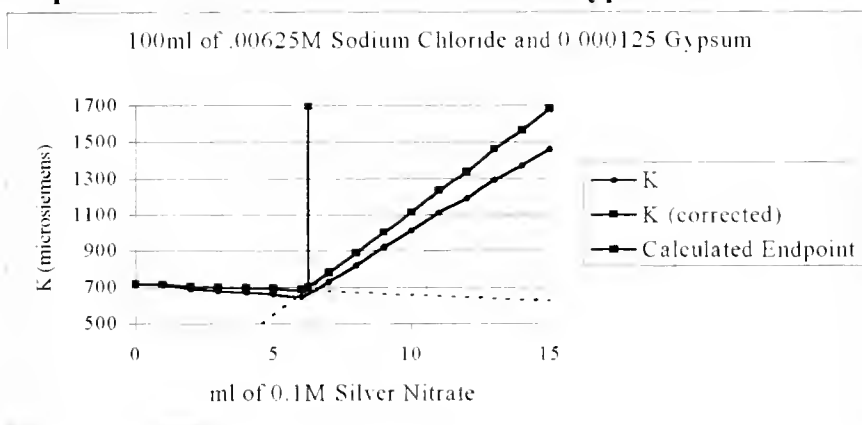
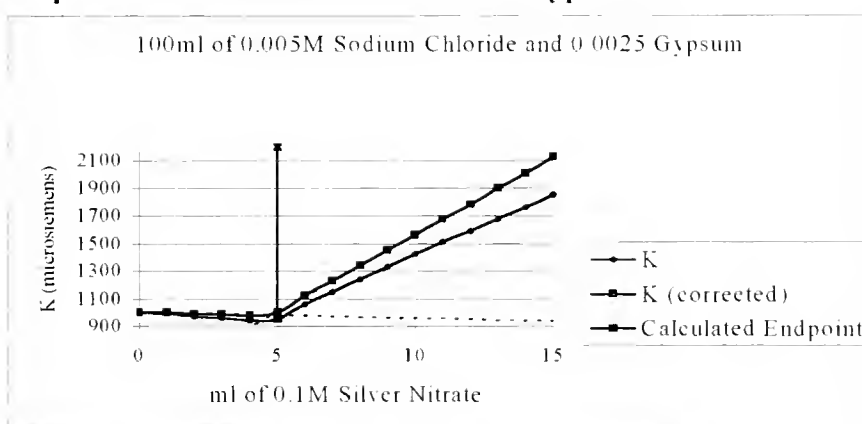
Test Titrations of Sodium Chloride in the Presence of Gypsum: Volume of Silver Nitrate vs. Conductance (K)

Graph 9: In the Presence of 0.000625M Gypsum

Graph 10: In the Presence of 0.000125M Gypsum

Graph 11: In the Presence of 0.0025M Gypsum

Since the solubility of gypsum is so much lower than that of sodium chloride, all of the solutions tested had a greater amount of sodium chloride than gypsum. All three titrations gave accurate results within a few milligrams. Like the single salt test titrations, the results understated the calculated content of sodium chloride. The gypsum did not have any effect on the titration of the sodium chloride.

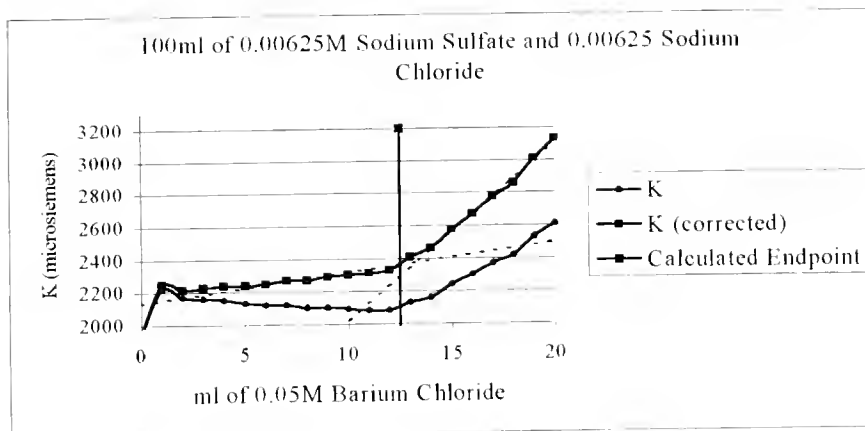
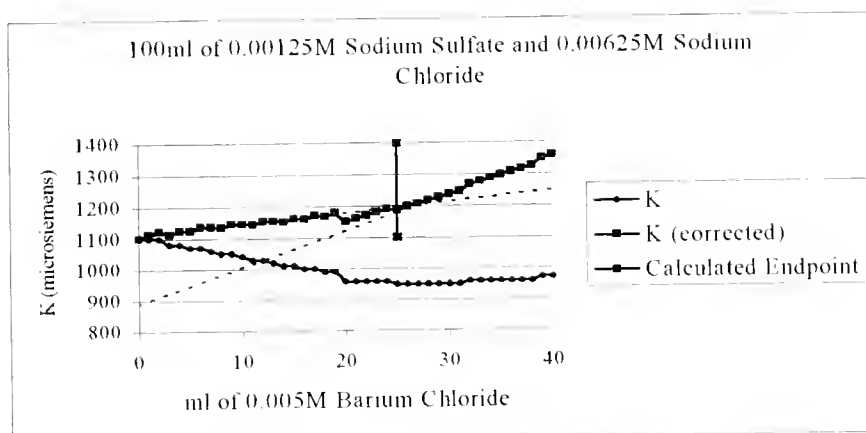
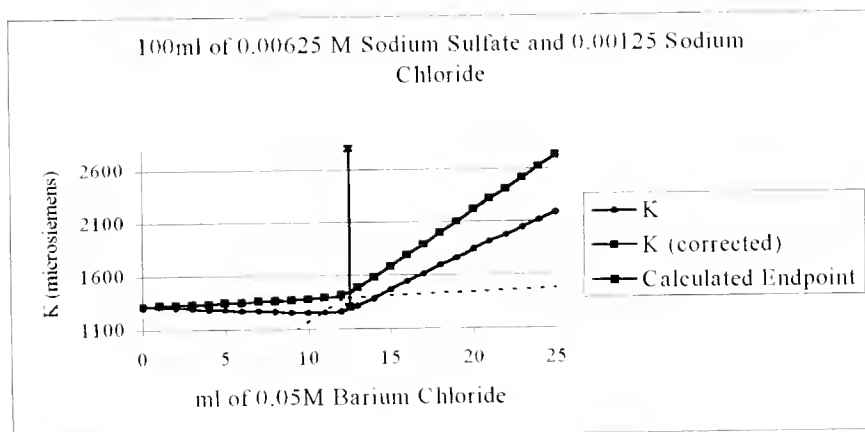
Test Titrations of Sodium Sulfate in the Presence of Sodium Chloride: Volume of Titrant vs. Conductance (K)

The fourth set of test titrations were used to verify the ability to determine the concentration of sodium sulfate in a sodium chloride solution (Table 9 and Graphs 12, 13, and 14). Again, the results show good accuracy. The difference between the calculated amount of grams and the titration amount of grams was within a few milligrams. All of these titrations gave a sodium sulfate concentration slightly higher than expected. Graph 13 illustrates the ability to determine the sodium sulfate content using a less concentrated titrant, 0.005M barium chloride. Just like the titrations using a titrant of a lower concentration of silver nitrate, the endpoint is less clear because the slope of the titration curve is smaller. In general, titrations for sodium sulfate when present with sodium chloride were not undertaken, since, estimating the concentration based on the conductance to molarity correlation curves gave accurate results.

Graph 12: In the Presence of 0.00625M Sodium Chloride

Graph 13: In the Presence of 0.00625M Sodium Chloride

Graph 14: In the Presence of 0.00125M Sodium Chloride

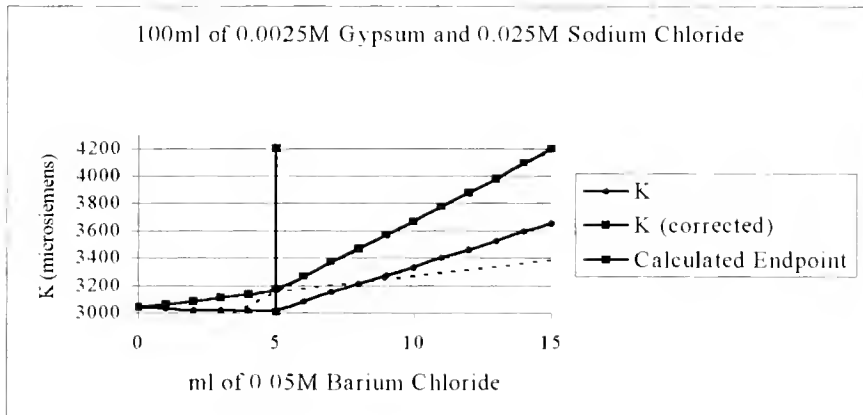
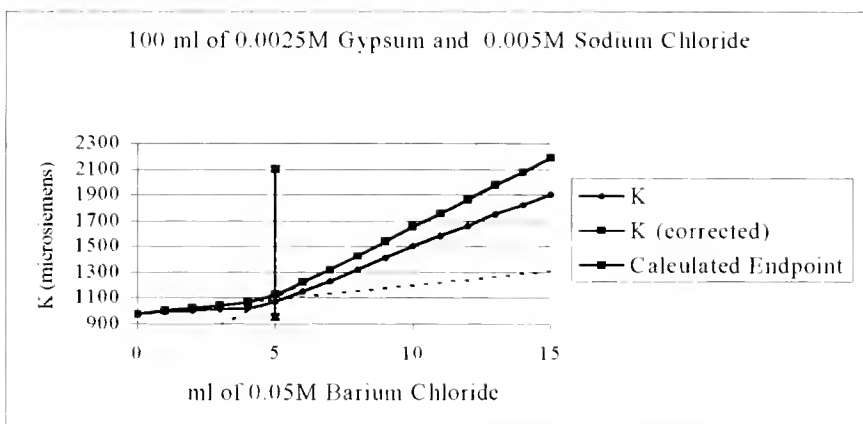
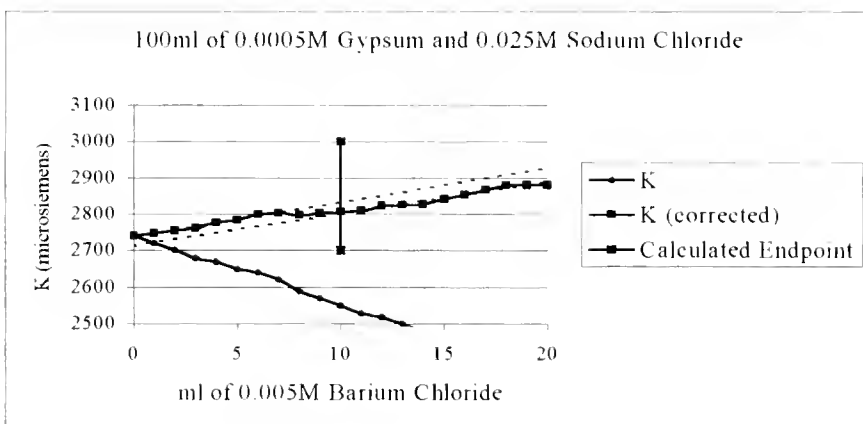
Test Titrations of Gypsum in the Presence of Sodium Chloride: Volume of Titrant vs. Conductance (K)

Graph 15: In the Presence of 0.025M Sodium Chloride

Graph 16: In the Presence of 0.005M Sodium Chloride

Graph 17: In the Presence of 0.025M Sodium Chloride

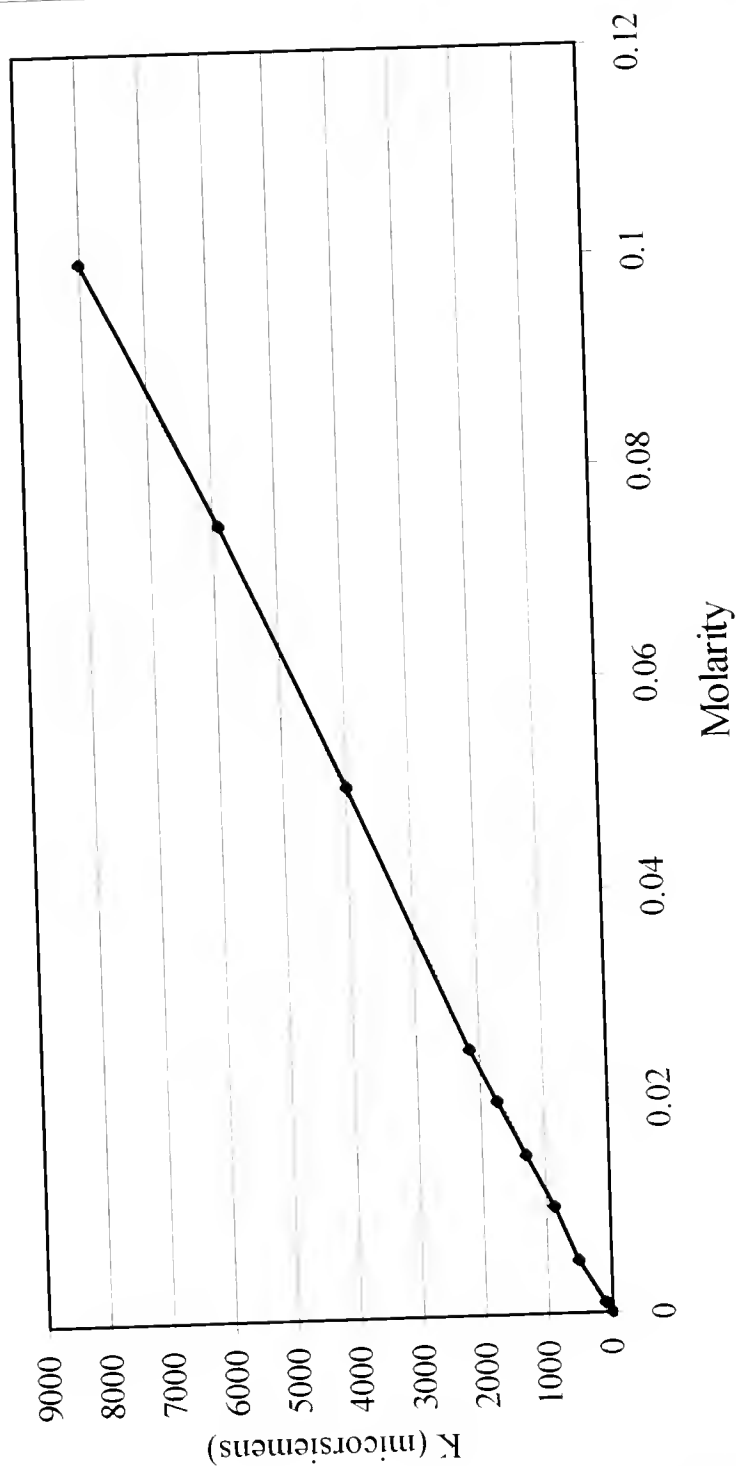
Graph 18: Sodium Chloride Conductance (K) Standardization Curve

Conductance to Molarity Correlation Curve:
Sodium Chloride

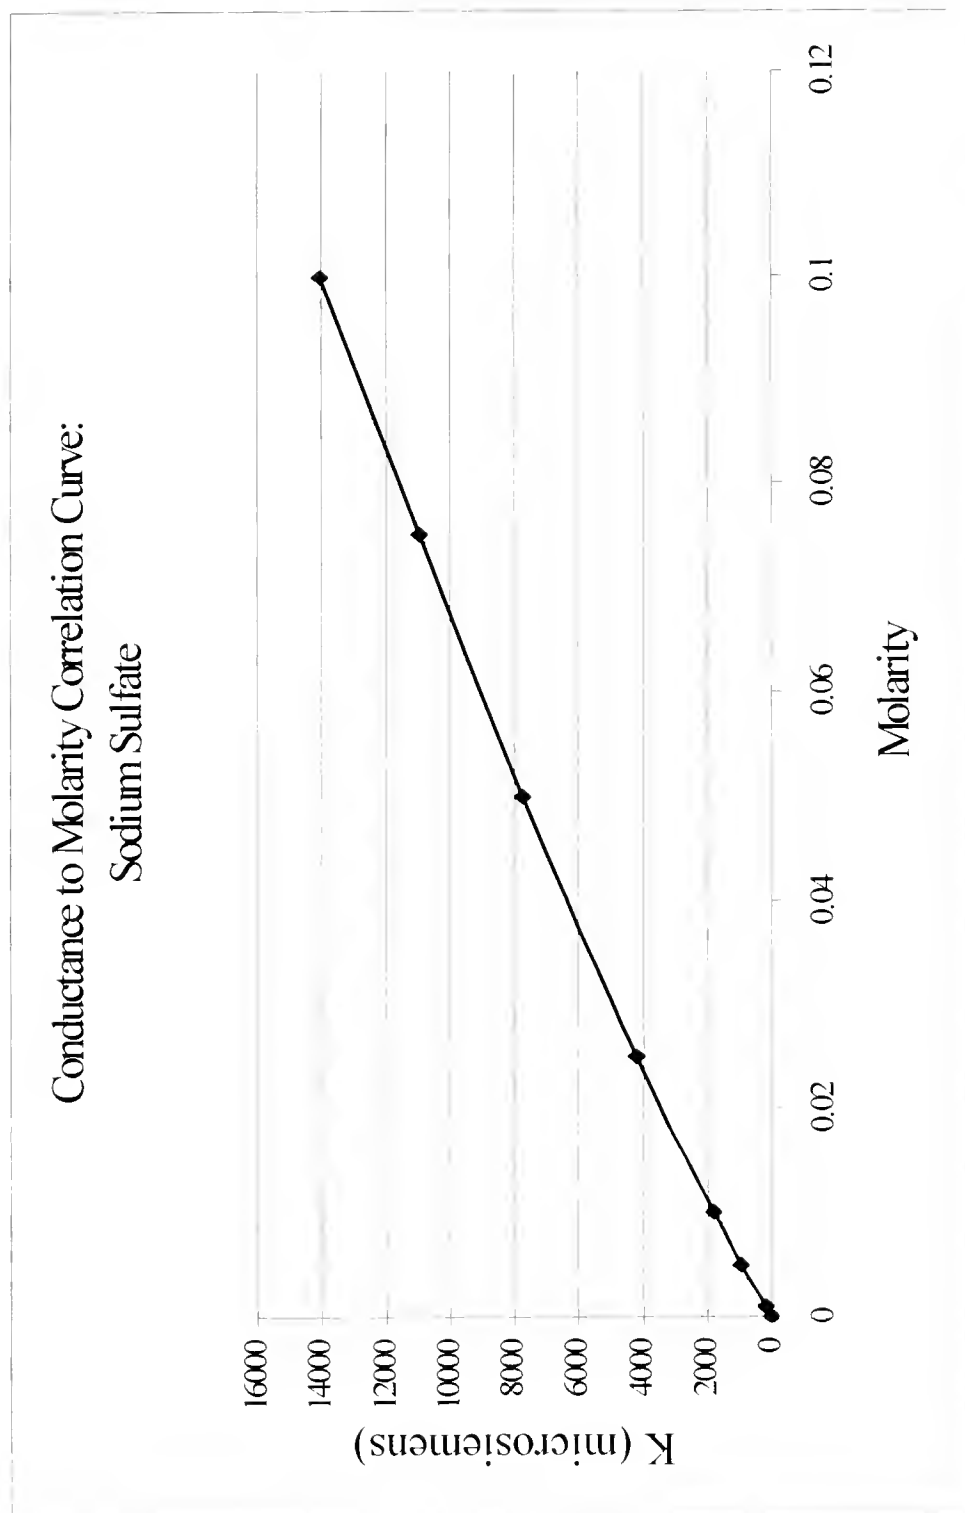
Graph 19: Sodium Sulfate Conductance (K) Standardization Curve

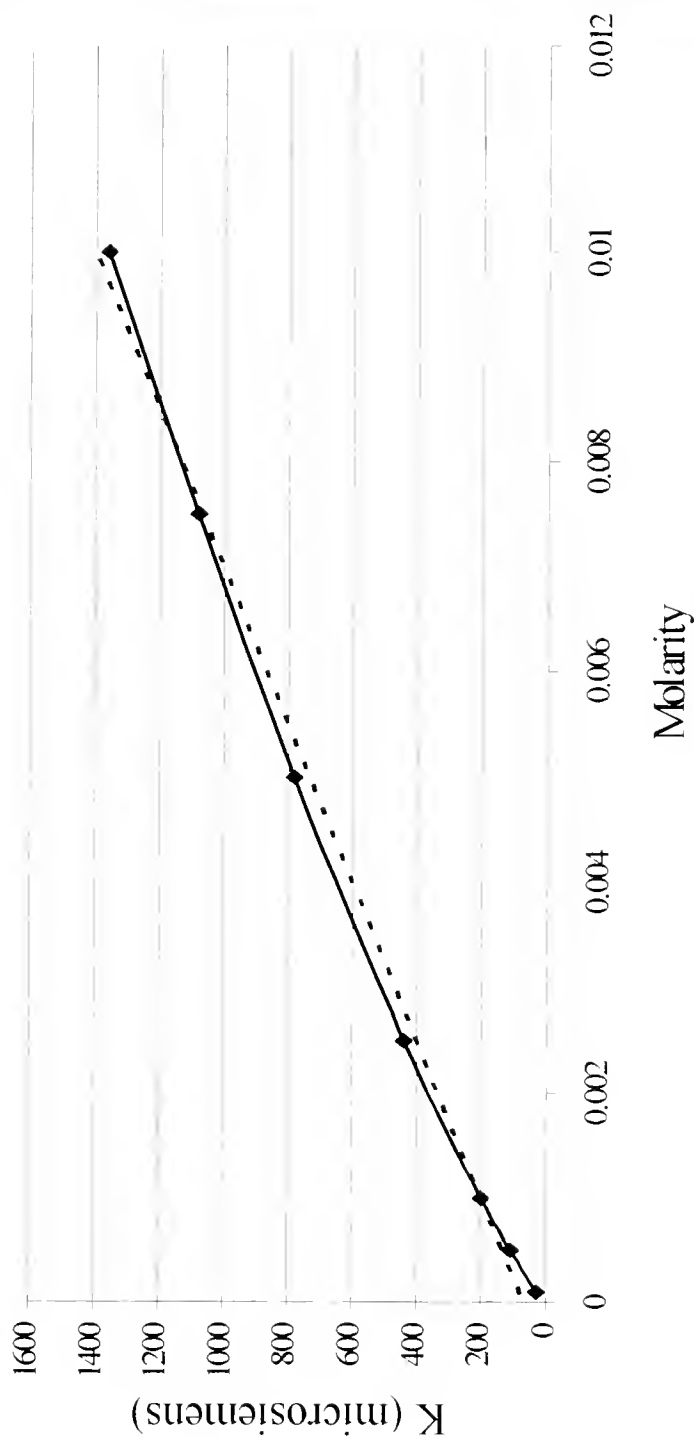
Graph 20: Gypsum Conductance (K) Standardization Curve

Conductance to Molarity Correlation Curve:
Calcium Sulfate Dihydrate

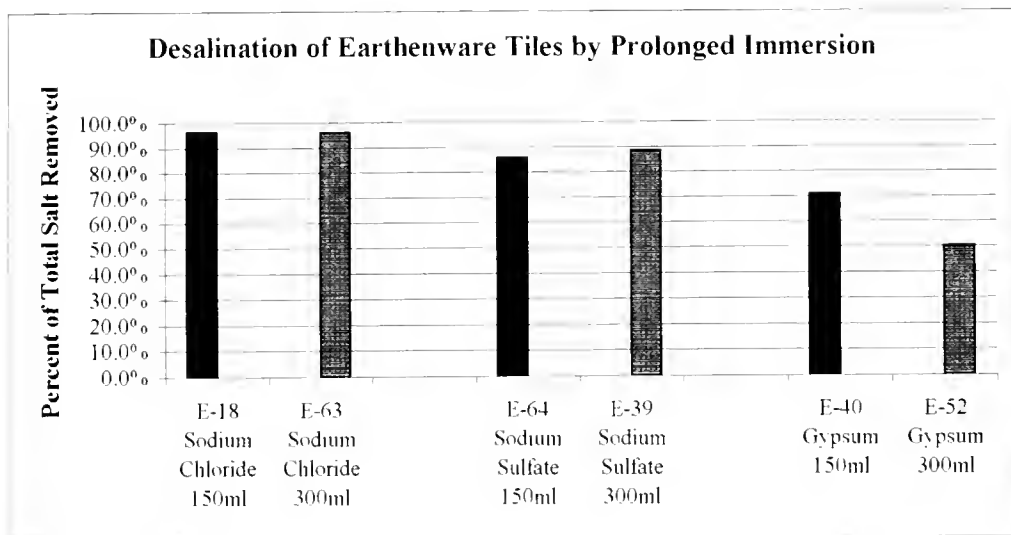
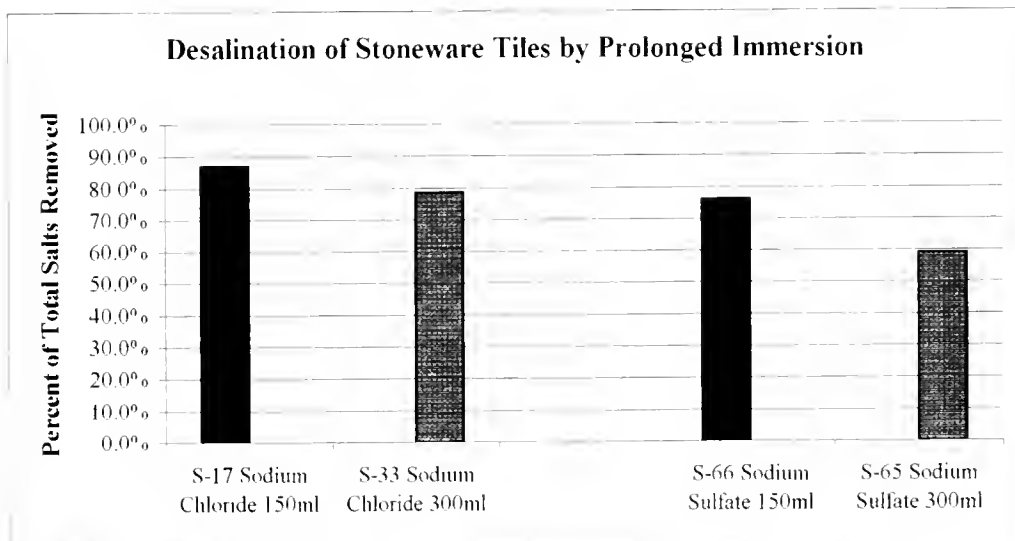
Graph 21: Comparison of Desalination by Prolonged Immersion

Graph 22: Comparison of Desalination by Prolonged Immersion

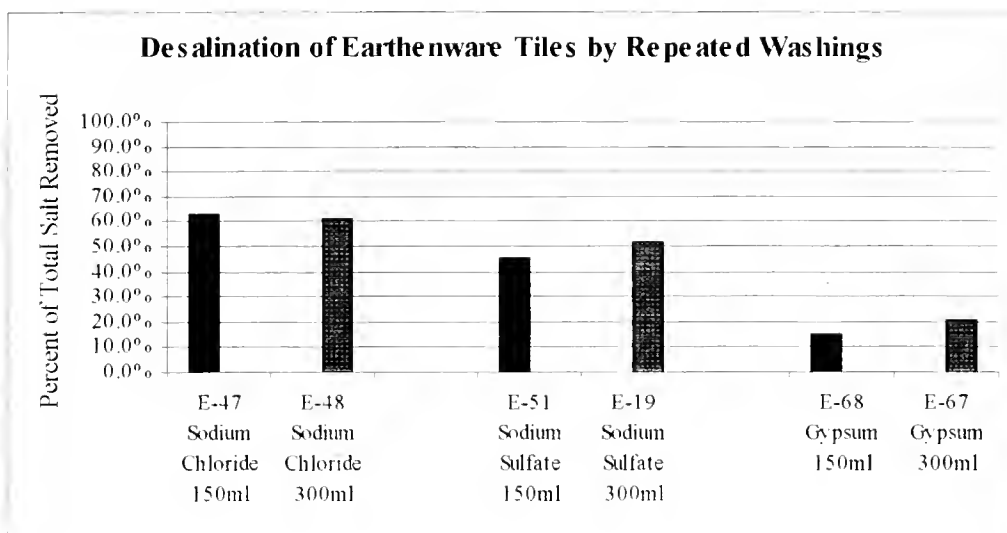
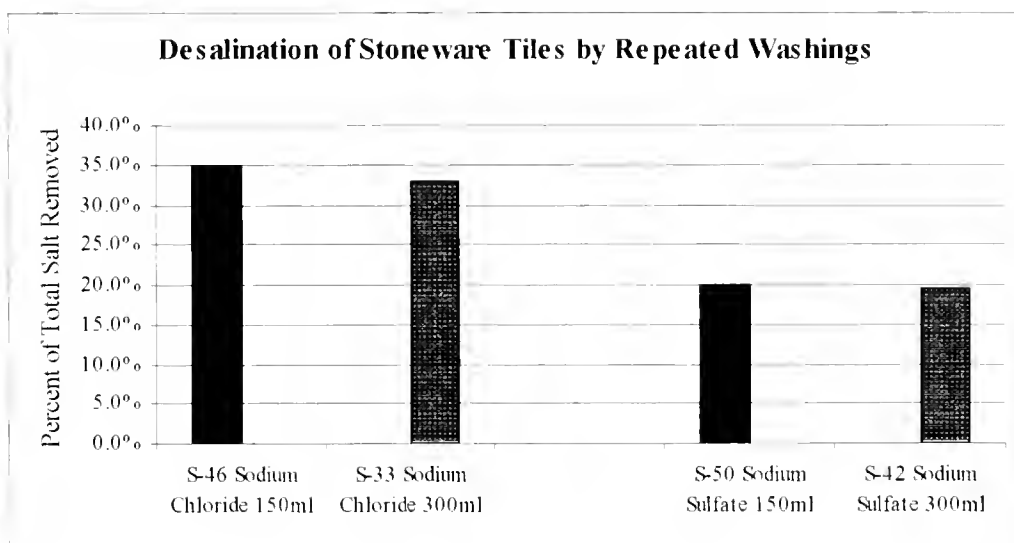
Graph 23: Comparison of Desalination by Repeated Washings

Graph 24: Comparison of Desalination by Repeated Washings

The results confirm that the amount of wash solution has no affect on the efficiency of the desalination of the salts from the ceramic tiles.

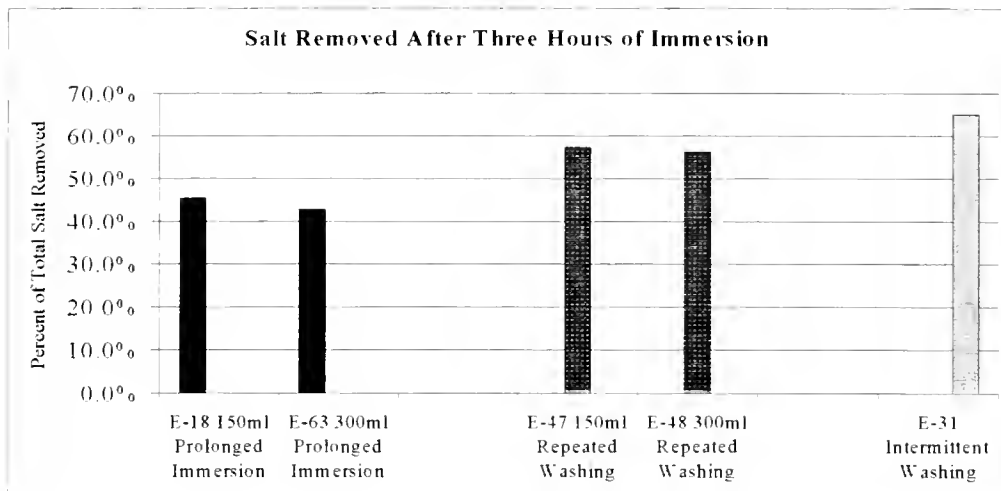
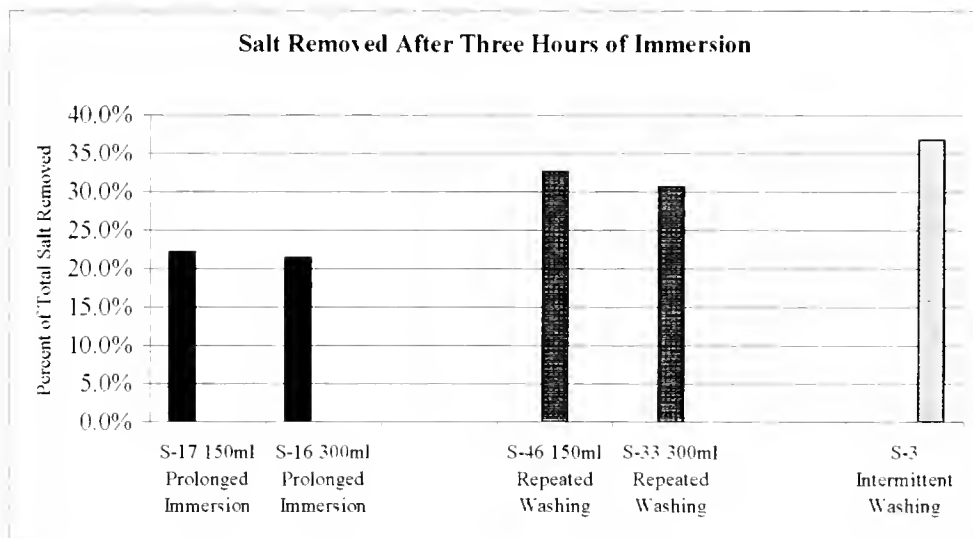
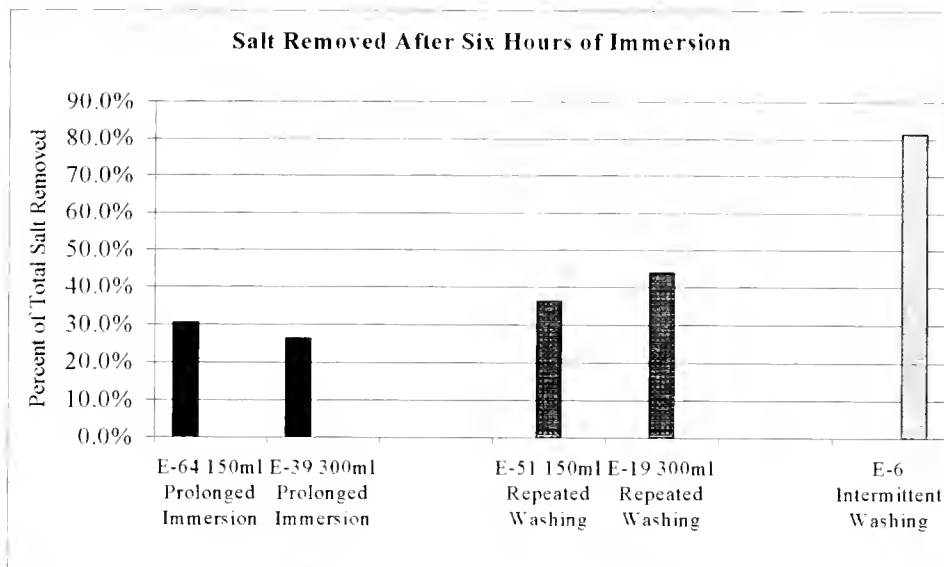
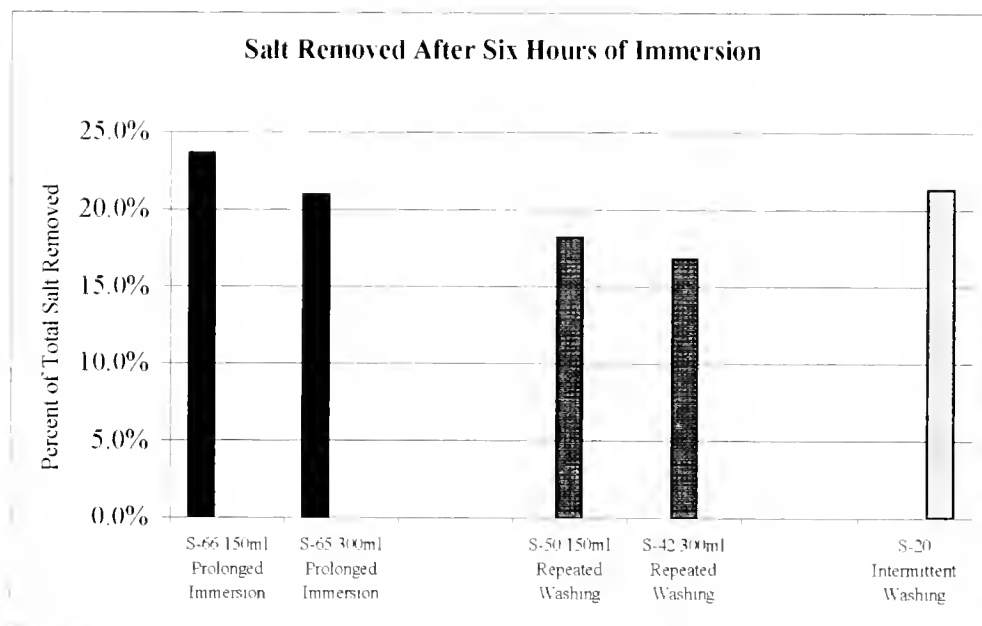
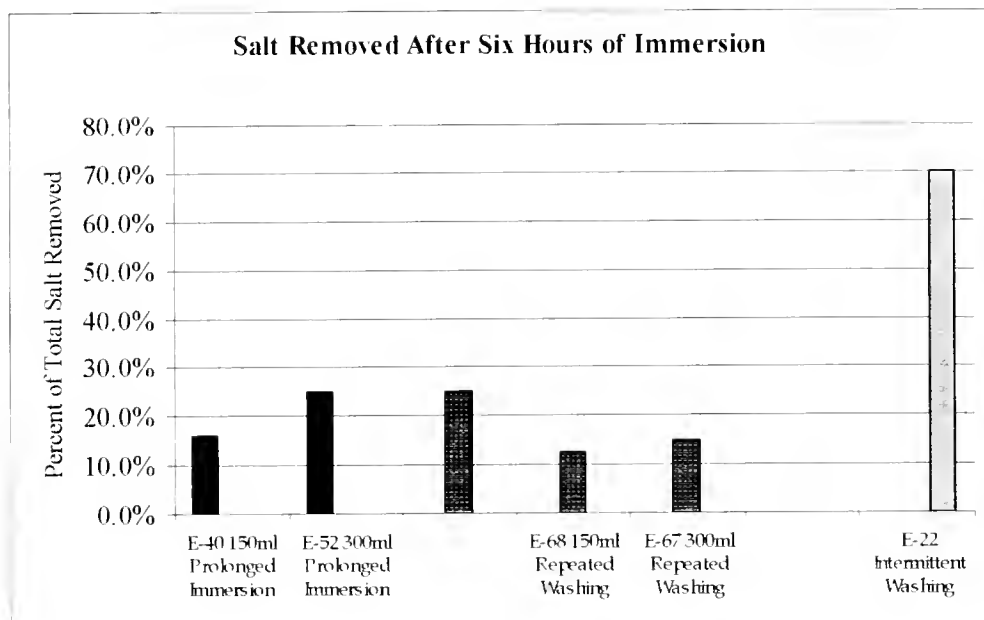
Graph 25: Comparison of Percent of Sodium Chloride Removed from Earthenware Tiles After 3 Hours in Water

Graph 26: Comparison of Percent of Sodium Chloride Removed from Stoneware Tiles After 3 Hours in Water

Graph 27: Comparison of Percent of Sodium Sulfate Removed from Earthenware Tiles After 6 Hours in Water

Graph 28: Comparison of Percent of Sodium Sulfate Removed from Stoneware Tiles After 6 Hours in Water

Graph 29: Comparison of Percent of Gypsum Removed from Earthenware Tiles After 6 Hours in Water

Even with only three cycles, the total amount of salt removed was equal or greater than the total amount of salt removed after five cycles of simple immersion for the same time. When compared to immersion after an equal amount of time, the differences are even larger (Graphs 25-29).
